Manhole Inspection Summary

Manhole # S13AA_011MH

Insp Date: **11/14/07 11:56 AM**

Location Address: **REAR 2800 MOSHER ST**

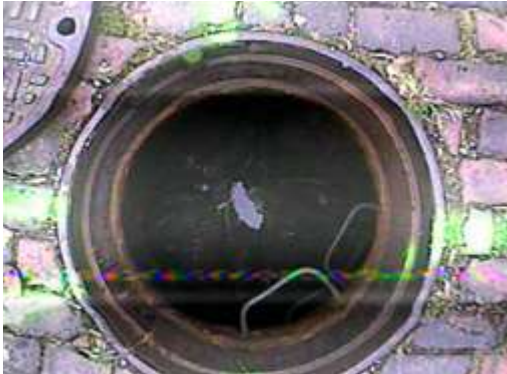
Top View

DEBRIS IN CHANNEL AND ON BENCH

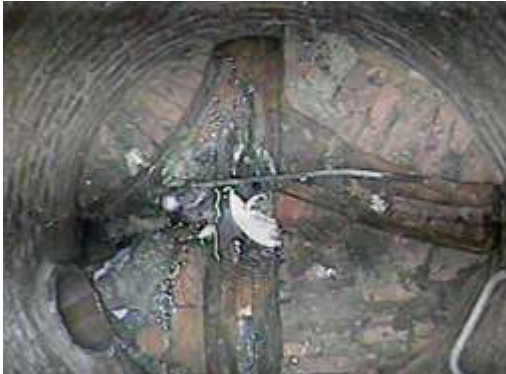
Defect 1

DEBRIS IN CHANNEL AND ON BENCH

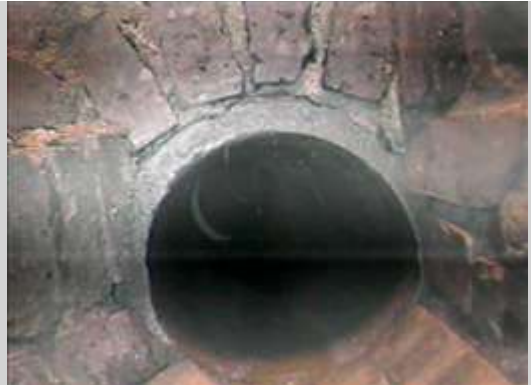
12 O'Clock Outflow

8 in. Circular Gravity Sewer
Pipe Out @ 12 O'Clock

Pipe Material: **Clay** ☐ Pipe Lined

Invert Depth: **7.65** (ft.) Flow Characteristics: **Slow**

Deposits: ☒ None ☐ Mud ☐ Sludge ☐ Debris ☐ Grease

Infiltration: **None** Pipe Seal Cond: **Sound**

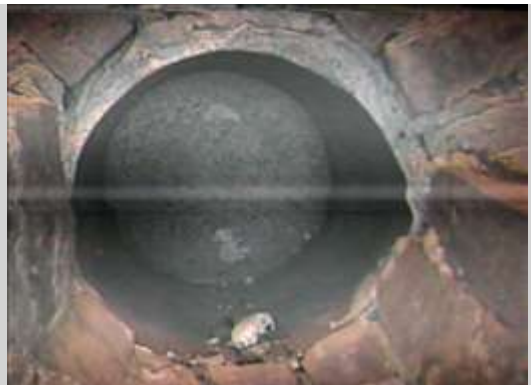
3 O'Clock Inflow

8 in. Circular Gravity Sewer
Pipe In @ 3 O'Clock

Pipe Material: **Clay** ☐ Pipe Lined

Invert Depth: **7.11** (ft.) Flow Characteristics: **Slow**

Deposits: ☒ None ☐ Mud ☐ Sludge ☐ Debris ☐ Grease

Infiltration: **None** Pipe Seal Cond: **Sound**

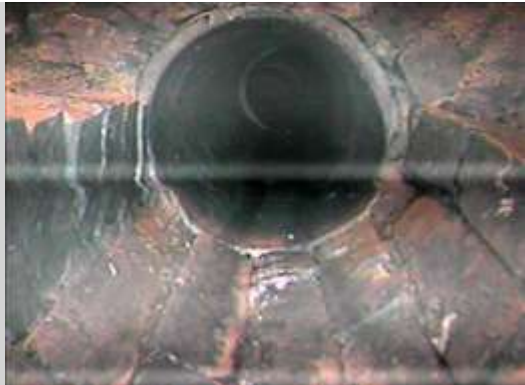
6 O'Clock Inflow

8 in. Circular Gravity Sewer

Pipe In @ 6 O'Clock

Pipe Material: **Clay** ☐ Pipe Lined

Invert Depth: **7.28** (ft.) Flow Characteristics: **Slow**

Deposits: ☒ None ☐ Mud ☐ Sludge ☐ **Debris** ☐ Grease

Infiltration: **None** Pipe Seal Cond: **Sound**

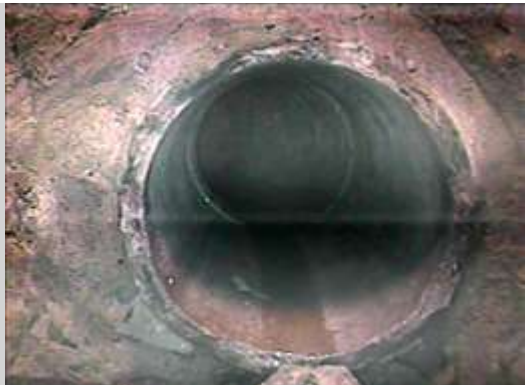
8 O'Clock Inflow

10 in. Circular Gravity Sewer

Pipe In @ 8 O'Clock

Pipe Material: **Clay** ☐ Pipe Lined

Invert Depth: **6.78** (ft.) Flow Characteristics: **Slow**

Deposits: ☒ None ☐ Mud ☐ Sludge ☐ **Debris** ☐ Grease

Infiltration: **None** Pipe Seal Cond: **Sound**

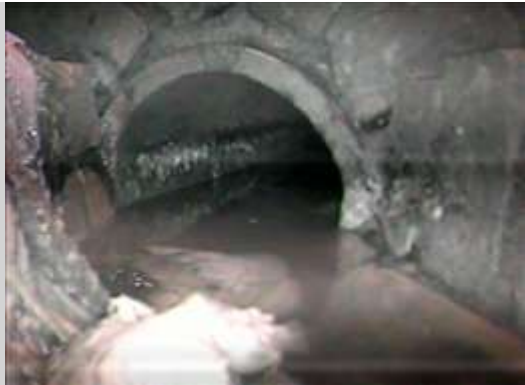
9 O'Clock Inflow

6 in. Circular Gravity Sewer
Pipe In @ 9 O'Clock

Pipe Material: **Clay** ☐ Pipe Lined

Invert Depth: **7.59** (ft.) Flow Characteristics: **Slow**

Deposits: ☐ None ☐ Mud ☐ Sludge ☒ **Debris** ☐ Grease

Silt Depth: **0** (in.) Deposits Extent: **Light**

Infiltration: **None**
